FIX FOR LATCH HAZARD

There's danger related to your unit's M1074A1 and M1075A1 PLS charge air cooler and radiator assembly doors. While working inside the engine compartment or in the path of the door frame, you could be struck or crushed against the engine or vehicle fender!

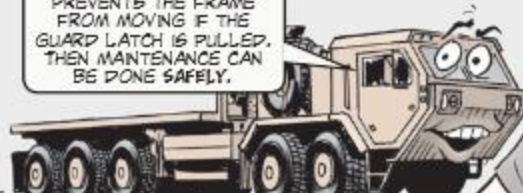
THE RATCHET STRAP PREVENTS THE FRAME FROM MOVING IF THE GUARD LATCH IS PULLED. THEN MAINTENANCE CAN BE DONE SAFELY.

BY THE WAY, THIS PROBLEM DOESN'T MAKE YOUR TRUCK NON-MISSION CAPABLE.
